Evidence for the breakdown of an Angkorian hydraulic system, and its historical implications for understanding the Khmer Empire

This paper examines the construction and design of a 7-km long embankment, probably built for King Jayavarman IV between 928 and 941 CE, as part of a new capital. We calculate that the capacities of the outlets were too small, and conclude that the embankment failed, probably within a decade of construction, so that the benefits of the reservoir stored by the embankment and the access road on top of it were lessened substantially. We explain how the design was sub-optimal for construction, and that while the layout had a high aesthetic impact, the processes for ensuring structural integrity were poor. Simple and inexpensive steps to secure the weir were not undertaken. We speculate that this early failure may have contributed to the decision to return the royal court and the capital of the Khmer Empire to the Angkor region, marking a critically important juncture in regional history.

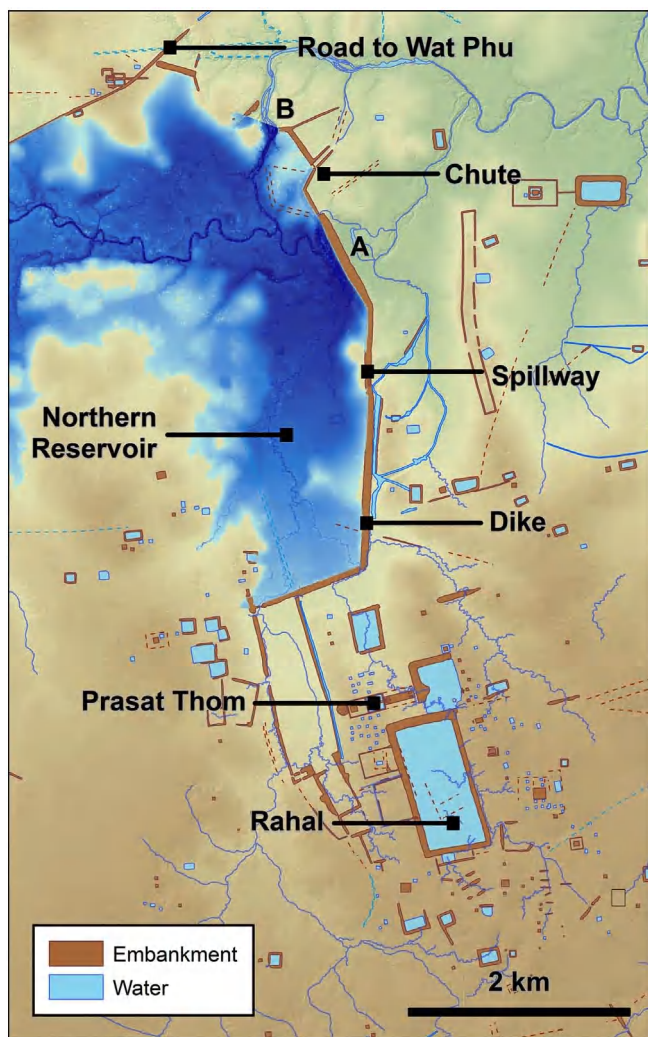
But this infrastructure was not to last. Whereas the Rongea River originally ran eastwards past Point A in Fig. 2, we see that it now runs northwards, having overtopped and broken through the embankment at Point B. Once this happened, the large lake, the unimpeded access road, and any economic benefits from the reservoir would have been lost. Did this happen before the political centre moved back to Angkor, and were the two events linked?

Fig. 2. Weir to north of Prasat Thom. It had two outlets, a spillway 190 m across, and a chute 230 m long with 4-m high walls 35 m apart. Note the N-S linear feature 1 km to the east of the main spillway. Imagery derived from KALC lidar data (Evans et al., 2013).

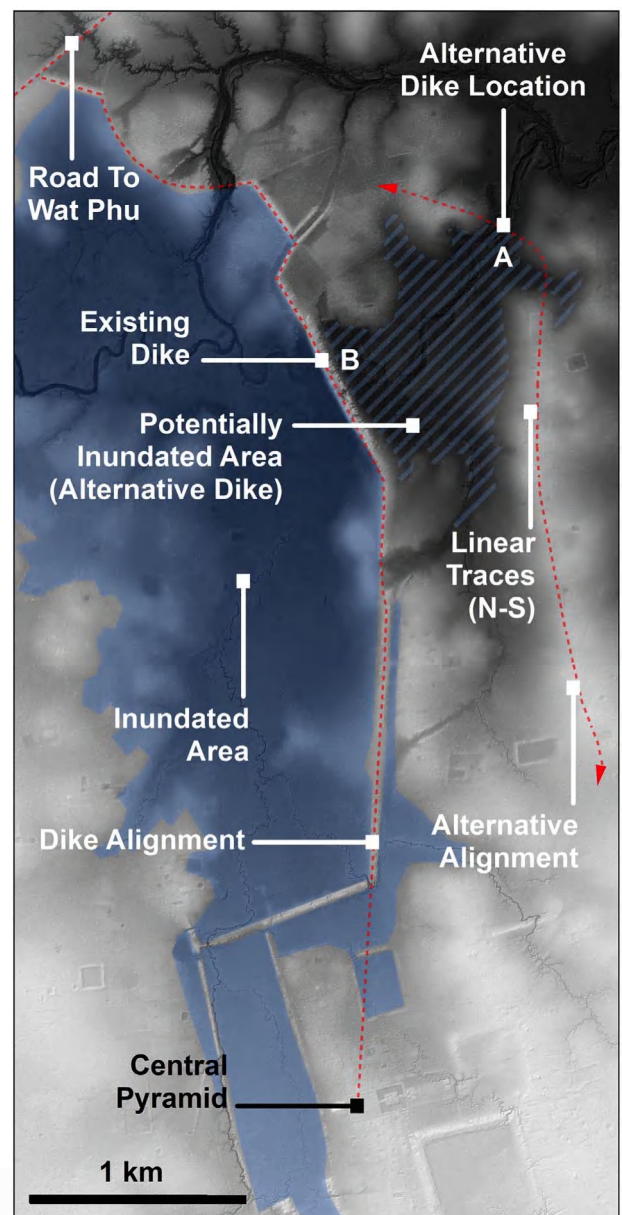
Fig. 3. Access road to Koh Ker past artificial lake formed by weir. The alternative dike location at A, to the north of the linear traces on high ground, would have been less costly to construct than the existing dike B. These linear traces indicate that an alternative access route was under active consideration. (The whiter the color, the higher the ground.)

This embankment was probably the only significant water management feature constructed during the time that the centre was at Koh Ker (Evans, 2010–2011, 107). While the route chosen for its construction was more costly than other alternatives, as indicated on Fig. 3, visitors to Koh Ker would have had an extensive body of water to their right, once they left the Wat Phu Road to enter the city, and then a direct line of sight to the central temple, Prasat Thom (Shimoda & Sato, 2009, 38). Routing the road along the adjacent high ground could have meant that the access road was as much as 200 m away from the water, and that Prasat Thom was no longer directly ahead. Had Jayavarman chosen the even higher ridge a kilometer to the east for the access route, the water views would have been even more distant and obscured in places by high ground to the west. We suggest from this that the aesthetic effects were a significant constraint on the design.

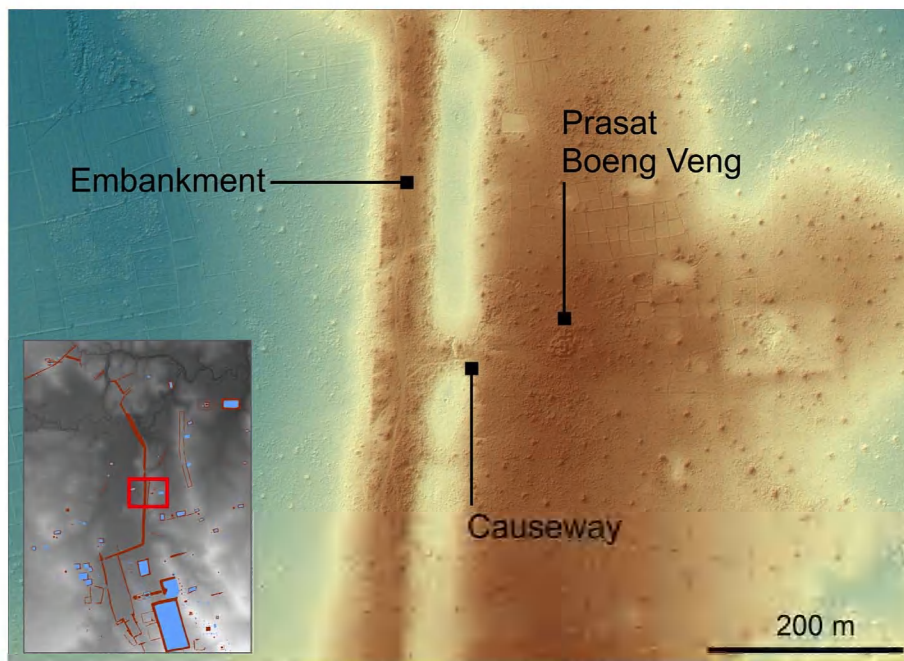
Fig. 4. Prasat Boeng Voeng linked to main embankment by causeway. Water has cut a channel through the causeway, and would have flowed every rainy season. (High elevation is brown, low elevation is blue.)

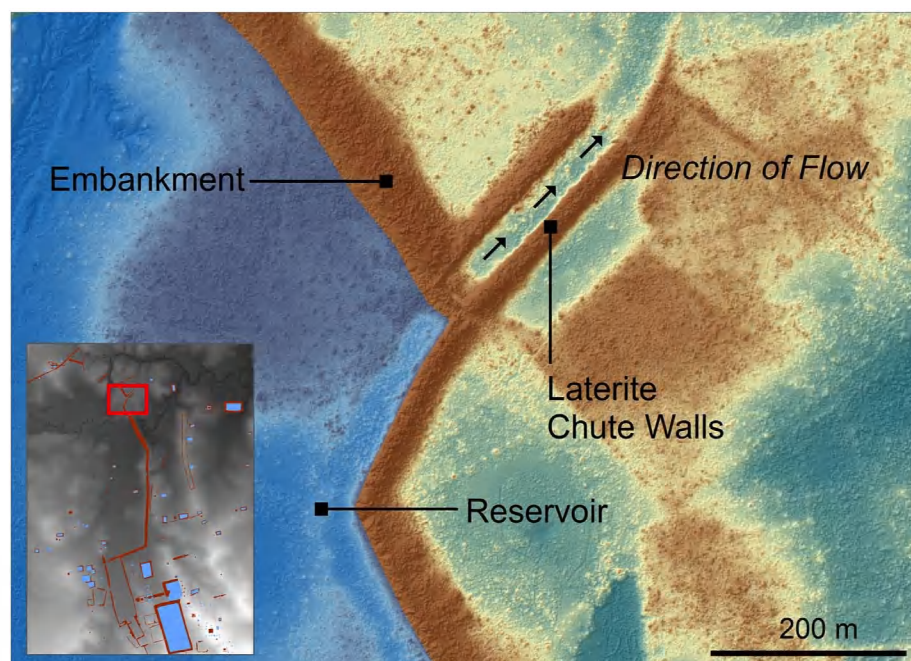
Fig. 5. Chute outlet. The laterite walls are about 4 m high at about 70.6 m ASL. See also Fig. SI 2.

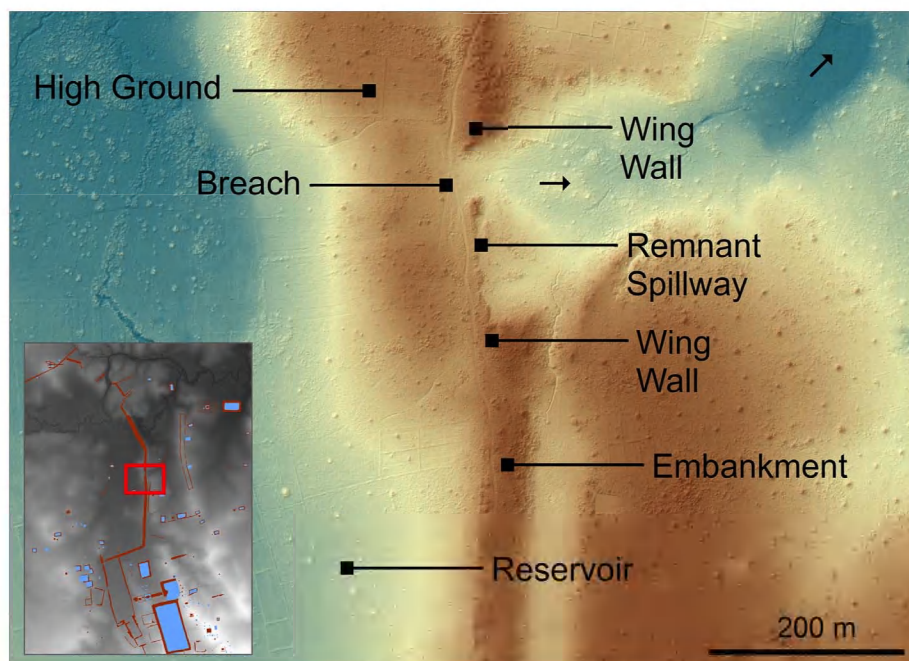
Fig. 6. Spillway with high ground upstream, and washed out at northern end. The tops of the wing walls are at about 70.6 m ASL. See also Figs. SI 3 and SI 4.

the high velocities of water flowing over the spillway. Laterite blocks have also been located as far as 500 m downstream, supporting the idea that the failure of the spillway was catastrophic. This major breach can be seen clearly (Figs. 6 and SI 3).

As illustrated in Fig. 11, the water flowing over a spillway accelerates as it passes over the crest, and then accelerates further as it runs down to the toe of the embankment. Near the bottom, the water plunges into turbulent water, and could undermine the foundations supporting the toe. The flow of water over the spillway seems to have undermined the laterite blocks where they rested on clayey sand, but not so much where they had been placed on sandstone, as this part of the embankment is still largely intact. Today, one would protect the toe by installing a mechanism for dissipating the high energy to protect against erosion, but this was not done here. Where the toe was undermined, a 50-m wide section of the spillway is missing. (See also Fig.

A deficiency in design that contributed to the failure of the embankment was that the spillway was founded on the low side of a sloping sandstone rock shelf. We judge from the lidar, together with surveys on site, that the elevation of the crest may have been originally at about 69.6 m ASL. However, there is a ridge of sandstone whose crest ranges from 68.9 m to 69.7 m ASL just upstream (to the west in Fig. 6). It is impractical to construct a spillway at a level that is at much the same level as a ridge just upstream. With the adopted layout, this high ground upstream would have impeded the flow of water from the reservoir to the spillway, so the structure's capacity for discharging excess flows was less than optimal.

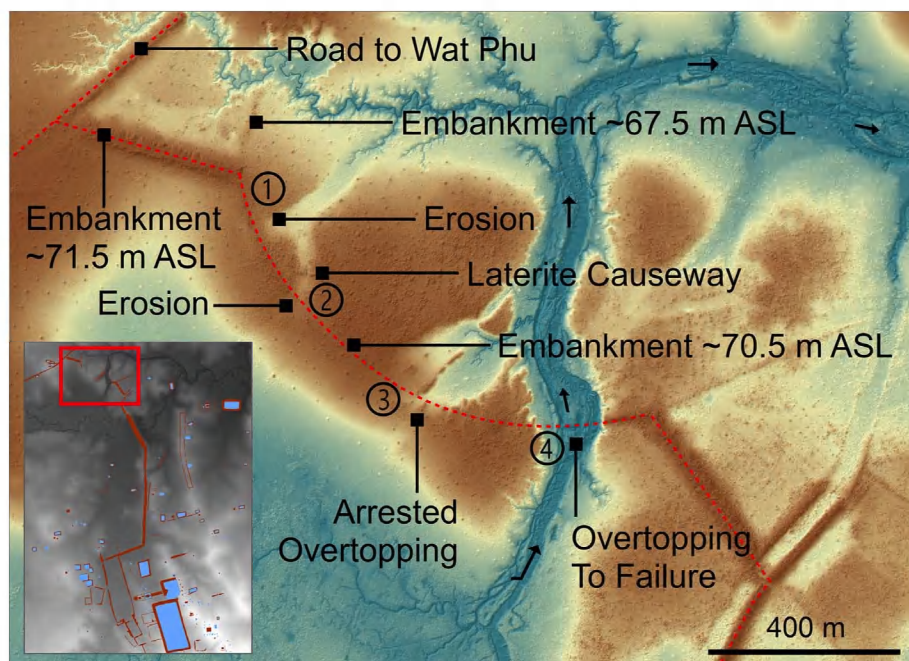
The erosion marks in Fig. 7 are too high to have been formed by natural runoff from the landscape, and are consistent with the ground being washed away by water from the reservoir. Points 1 and 2 show erosion less than at Points 3 and 4. But if we look more closely at Point

Fig. 7. Northwestern section of embankment. The high embankment meets a possibly older embankment, which appears to have been eroded by water from the reservoir when it overtopped the first time. The embankment seems to have been replaced with a new one (Points 1 and 2). Both sections seem to have eroded a second time, possibly when there was also overtopping further east (Points 3 and 4), with the river forming at Point 4.

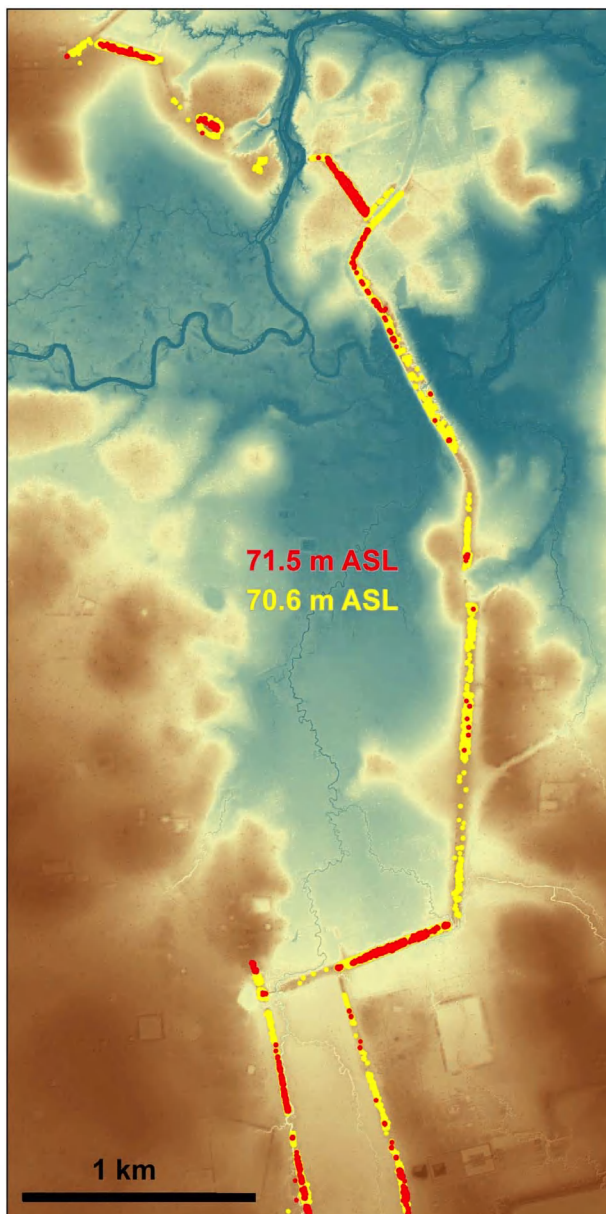
This section outlines evidence for the embankment being overtopped twice. Much of the embankment is still higher than 70.6 m, and some is above 71.5 m ASL today (Fig. 8), so it is reasonable to suppose most of it was initially higher than now and has since eroded.

Fig. 8. Embankment showing where the crest is at or above 70.6 m ASL (yellow) and 71.5 m ASL (red), respectively.

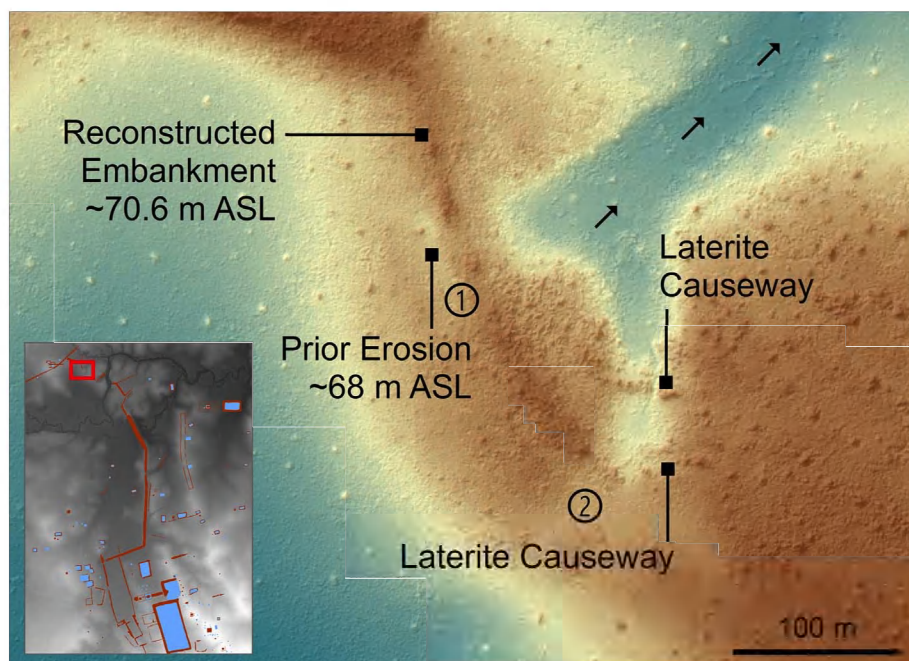
1 in Fig. 9, we see that the natural ground appears to have been eroded down to about 68 m ASL, then filled in with a 2.5 m-high embankment — if our assumption that the level of the crest was built up to around 70.6 m ASL the second time is correct.¹¹ Then this embankment was eroded again, in places, down to about 69 m ASL. At Point 2, the erosion apparently lowered the ground and formed a shallow gully on the downstream side. Two laterite pavements have been constructed across this gully, presumably after the first overtopping. These are not horizontal, suggesting that they have settled since, perhaps because their sandy-clay foundations became super-saturated and lost strength. Erosion Points 3 and 4 are shown in more detail in Fig. 10. The shape of the ground at Point 3 is consistent with the patterns created in soil when eroded by water overtopping about 200 m of a level embankment. At Point 4, the erosion was so great that a new river channel formed.

Fig. 9. Overtopping Points 1 and 2 showing indications of prior erosion having been covered over with reconstructed embankment, estimated to be at 70.6 m ASL. The lighter the colour, the higher the ground. The low ground at Point 1 at elevation ~68 m ASL appears to be the remnants of a channel created by erosion during the first overtopping, which was then filled in before being overtopped and eroded again. The laterite causeways at Point 2 would have been built after the first overtopping, which formed the channel there.

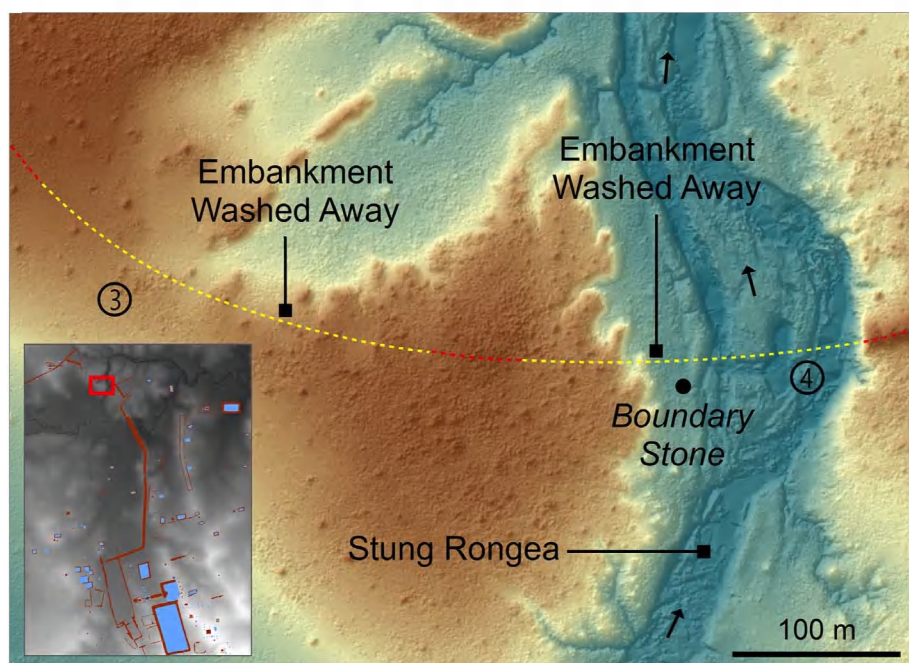
Fig. 10. Overtopping Points 3 and 4. Boundary stone in line with embankment on left bank of the Stung Rongea indicates that the embankment initially continued westwards along high ground. The yellow dotted line shows an approximate line of embankment, before being washed away.

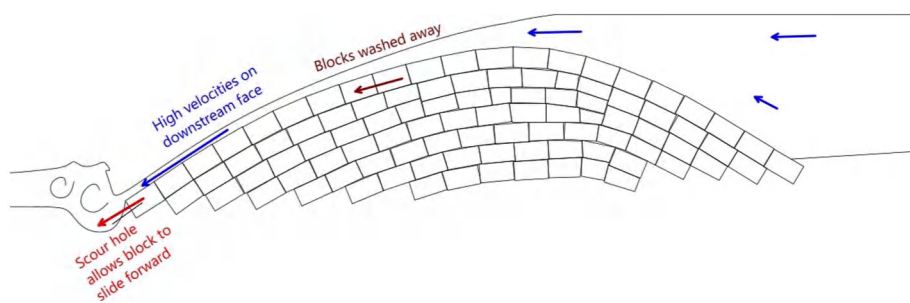
Fig. 11. Schematic diagram of laterite spillway showing zone of scour by water flowing over the ogee-form spillway.

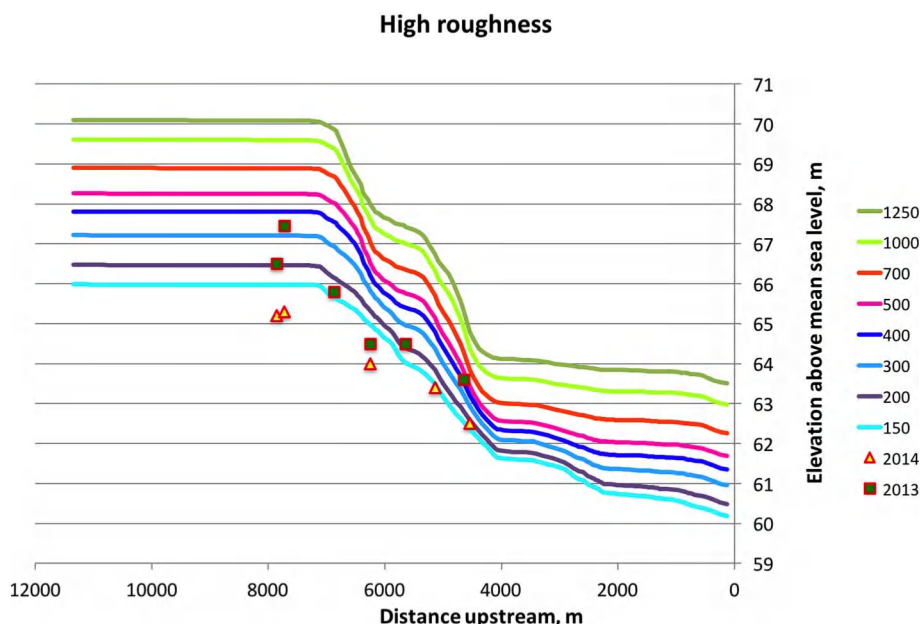
Fig. 15. HEC-RAS model results, assuming higher roughness values than normal. Points are peak water heights observed by local informants in 2013 and 2014.

against the flows derived from the HEC-RAS hydraulic model, we estimated that the flow may normally be no less than 120–300 m³/s every year, and may exceed 300–700 m³/s on average one year in ten. The lowest estimated flows are calculated on the assumption of higher than estimated values of roughness in the river and the floodplain. The highest flows are for lower than estimated values of roughness. In what follows, we assume the high-roughness flows, so that our conclusions will be conservative (Fig. 15). The results for normal values of roughness and for roughness less than normal are in Supporting Information SI 4.¹⁶

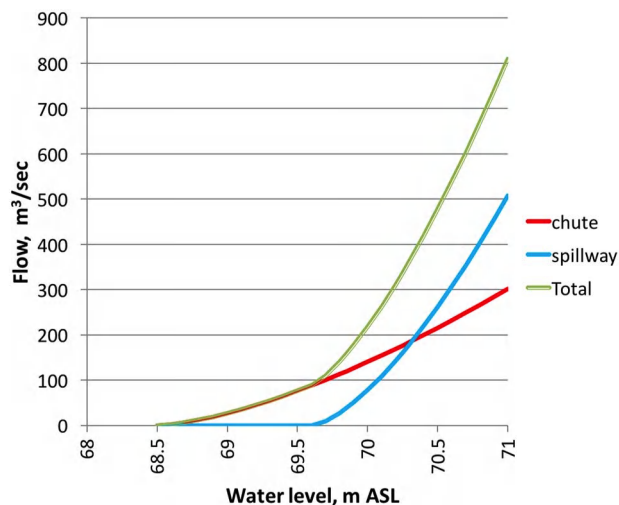
Fig. 16. Flow over both spillways increasing with water level in reservoir.

We next estimated the capacity of the chute and the spillway to pass river flows during the rainy season without overtopping the crest of the embankment. We calculate that the main spillway would have started flowing when the flow through the chute exceeded 90 m³/s, which could have been most years, since, according to the results of our preliminary hydrological modeling discussed below, the annual maximum flow would rarely have been less than 100 m³/s. We determined that the capacity of the chute and the spillway combined would have been about 220 m³/s when the elevation of the water level in the reservoir was 70 m ASL, and perhaps 540 m³/s if the elevation of the water level in the reservoir reached 70.6 m ASL (Fig. 16). The capacity of the chute and the spillway combined would have been exceeded when the inflow was > 540 m³/s. One implication from this is that with water flowing over the chute spillway throughout the rainy season, and over the main spillway probably at least during the wettest months, it may not have been possible to undertake small repairs to these structures until the following dry season.

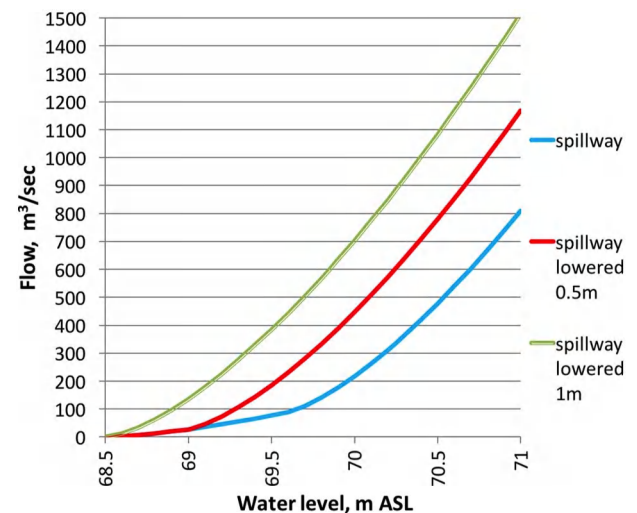
Fig. 17. Total flow over spillway and chute, and with spillway lowered.

spillway. Fig. 17 shows that the embankment could have been protected by lowering the crest of the main spillway by between half a meter and a meter. The capacity of the spillway would then have increased substantially, and the level of the reservoir during floods would have been lower as well, making the risk of overtopping negligible. Another option could have been to increase the width of the chute, thereby enlarging its capacity. It is possible that the danger of the embankment overtopping even with the crest at 70.6 m ASL may not have yet become apparent, because the combined capacity of the spillway and chute was found to be adequate for the flows that had been experienced till then.

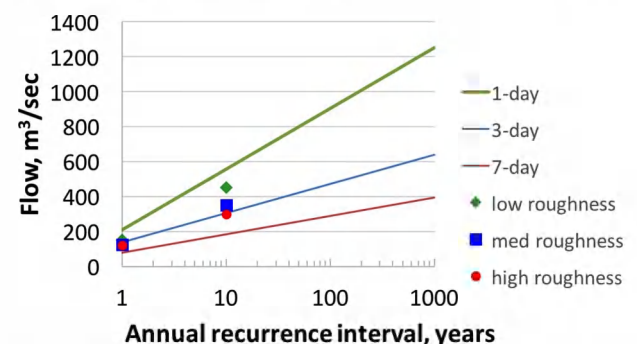
This scenario assumes simply that there has been a large and rare flood. The flood frequency derived by using the information from the villagers is plotted in Fig. 18 together with the results from the hydraulic modeling. The results from the hydraulic modeling were less than from the hydrological modeling for the 1-day flows, suggesting that the observed water levels may have been less than the actual peak. The maximum elevations reached in the reservoir are shown in Fig. 19 for the 3-day average modeling and Fig. 20 for the 1-day average modeling. The 3-day modeling indicated that the water level could

Fig. 18. Flood-frequency curve, derived from local and regional data. Markers indicate the results from the hydraulic modeling.

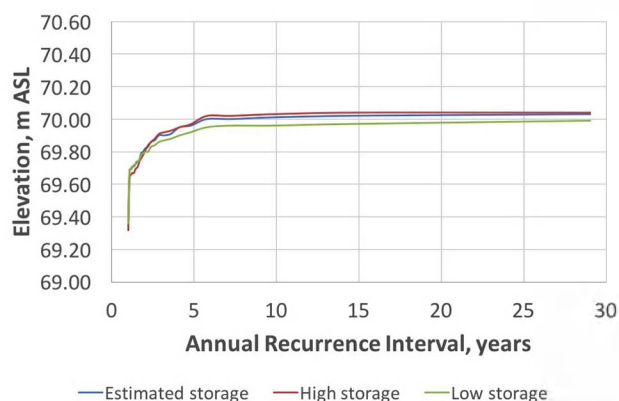
Fig. 19. Frequency of reservoir reaching different elevations, depending on estimated storage assuming a 3-day averaging of rainfall.

reach only 70 m ASL, whereas the level assumed for overtopping the embankment was 70.5 m. The 1-day model showed that the reservoir would rise to 70 m one year in three, but the 70.5 m level might be reached once in 15 years on average. However, this scenario for overtopping was judged not to be feasible, since the time taken to reach peak water level in the reservoir was anything from 3 to 60 h, and if it is agreed that the spillway and the embankment failed together, these times would be too long. This scenario, therefore, does not appear feasible.

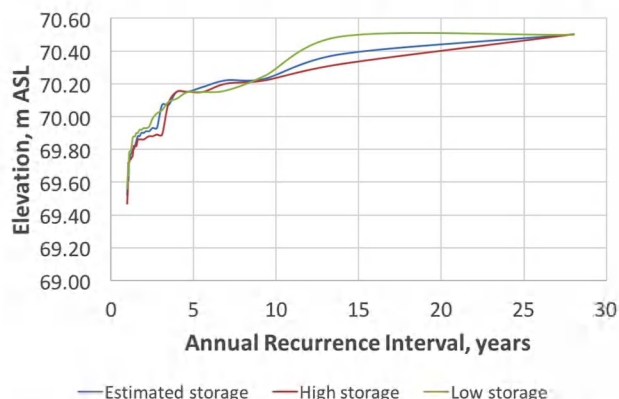
Fig. 20. Frequency of reservoir reaching different elevations, depending on estimated storage assuming a 1-day averaging of rainfall.

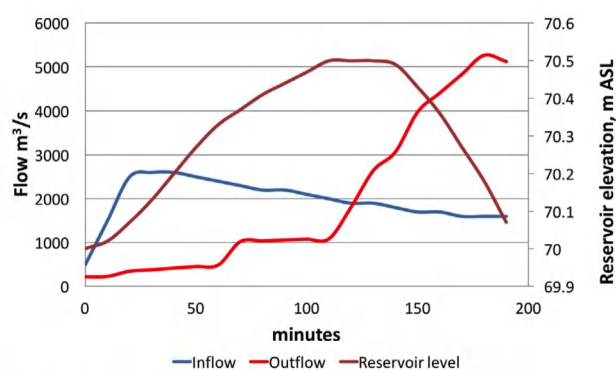
We first used the model to find the inflow, which could result in the reservoir level rising from 70 m to 70.5 m ASL within 2 h.¹⁷ Fig. 22 shows an inflow that simulates what is usually observed during floods, namely a rapid rise and a slow decline. We found by trial and error that the maximum flow might need to reach about 2600 m³/s for an embankment with a low point at 70.5 m ASL to overtop.¹⁸

Fig. 22. Inflows, outflows and water level for overtopping by large inflows into reservoir.
